Sea View Villas C.A.
Hermosa Beach, CA

Report #: 621-10
Beginning: January 1, 2025
Expires: December 31, 2025

RESERVE STUDY
Update "With-Site-Visit"

November 18, 2024

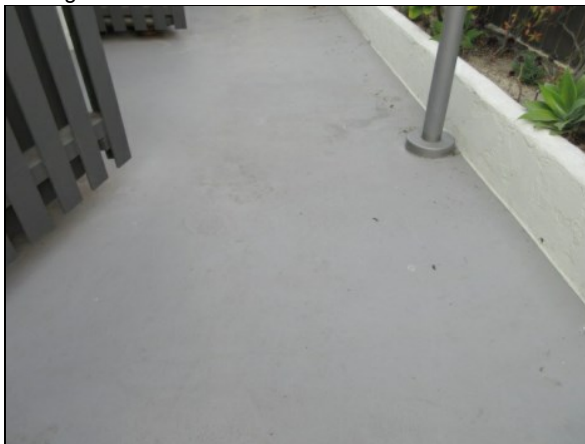
Comments: Regularly scheduled resealing projects will help extend the useful life of the decking membranes by bridging small surface cracks, while protecting the decking from damaging weather elements. The structural integrity of the decks were not verified as part of the scope of this Reserve Study. The decks should be inspected on a regular basis by your decking service company or by a licensed structural engineer.

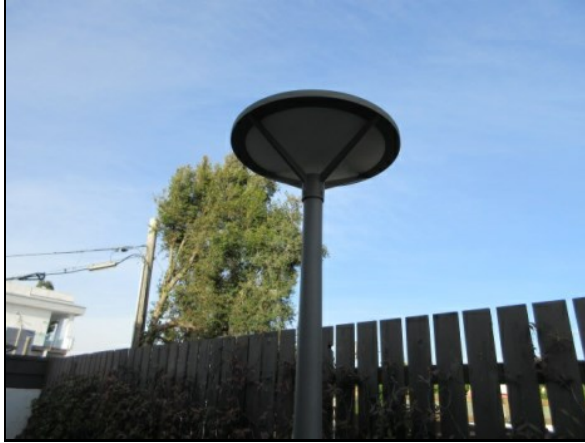
Comments: Inspected during daylight hours, but assumed to be functional. Fixtures should be cleaned on a regular basis to allow full illumination. Funding for eventual complete replacement to maintain a uniform appearance.

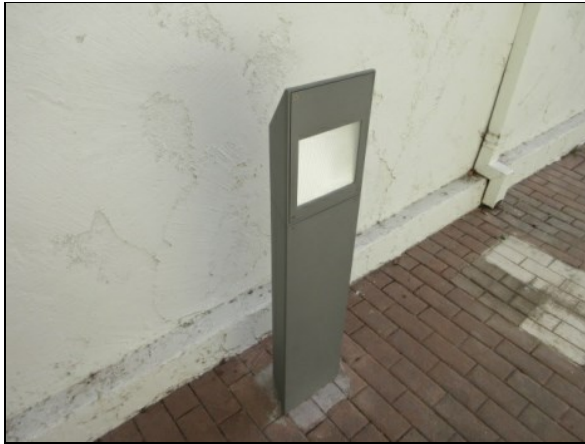
Comments: Inspected during daylight hours, but assumed to be functional. Funding for complete replacement projects to maintain a uniform appearance.

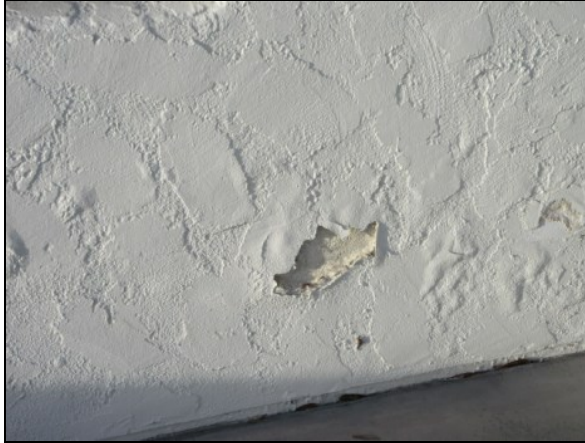
Comments: The stucco surfaces appear to be aging normally. No major damage observed. Funding for periodic repainting projects to maintain an attractive exterior appearance. Stucco repairs should be included as part of each repainting project. In general, stucco should be repainted every 10-20 years. This project should be coordinated with other surfaces (wood & metal) whenever possible to lower the overall cost of repainting. The cost of scaffolding has been added to the cost projections if necessary.

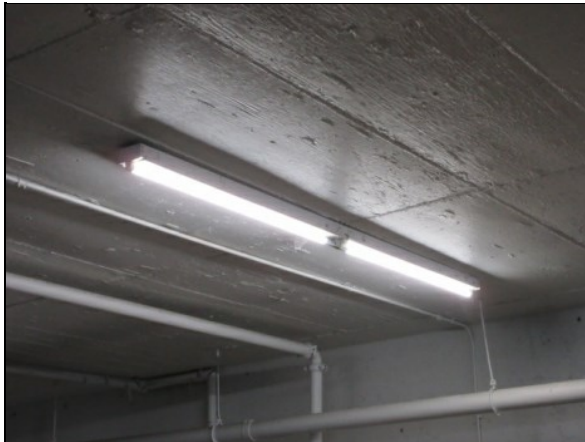
Comments: These fixtures are non-decorative in appearance. However, complete replacement projects are periodically required to maintain reliability, and to ensure optimal energy savings. Funding provided is for LED fixtures.
