Sea View Villas C.A.
Hermosa Beach, CA

Report #: 621-10
Beginning: January 1, 2025
Expires: December 31, 2025

RESERVE STUDY
Update "With-Site-Visit"

November 18, 2024

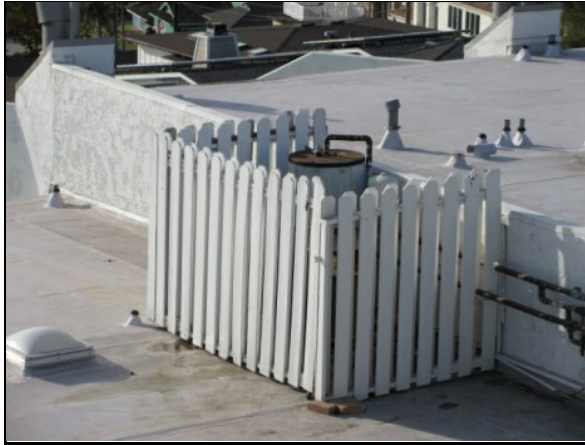
Comp #: 803 Water Storage Tank - Replace (West)**Quantity: (1) 115 Gal**

Comments: Water storage tanks typically last 10-12 years. The tank should be flushed annually as an Operating expense. Water storage tanks should be replaced proactively based on age and service vendor recommendations since failure is usually very sudden and could result in expensive interior damage and prolonged down-time while the heater is being replaced.

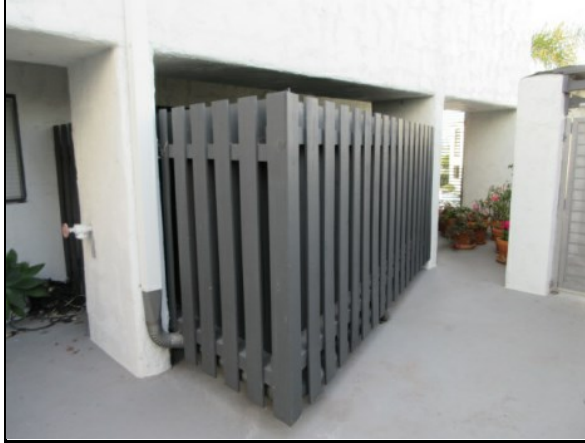
Comments: The stucco surfaces appear to be aging normally. No major damage observed. Funding for periodic repainting projects to maintain an attractive exterior appearance. Stucco repairs should be included as part of each repainting project. In general, stucco should be repainted every 10-20 years. This project should be coordinated with other surfaces (wood & metal) whenever possible to lower the overall cost of repainting. The cost of scaffolding has been added to the cost projections if necessary.

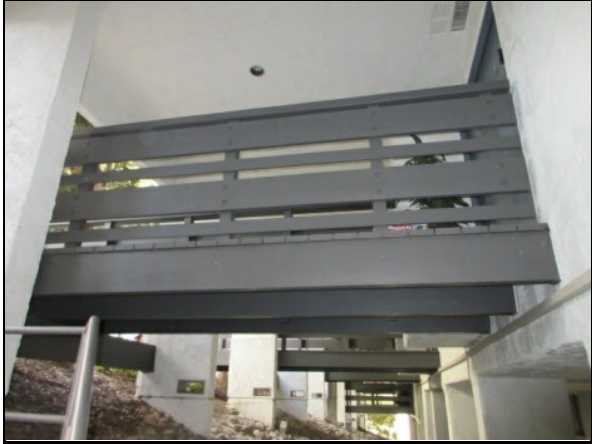
Comments: Exterior wood surfaces should be repainted on a regular basis in order to protect the surfaces from damaging weather elements and termite infestation. Wood surfaces should be repainted every 4-6 years in mild climates, and every 2-3 in beach or alpine climates. Repainting on schedule will decrease ongoing wood repair costs dramatically, while maintaining attractive exterior appearances. The repainting of the wood surfaces should be coordinated with other surfaces, such as stucco and metal, whenever possible to lower the overall cost of repainting and to utilize the same scaffolding at certain projects.

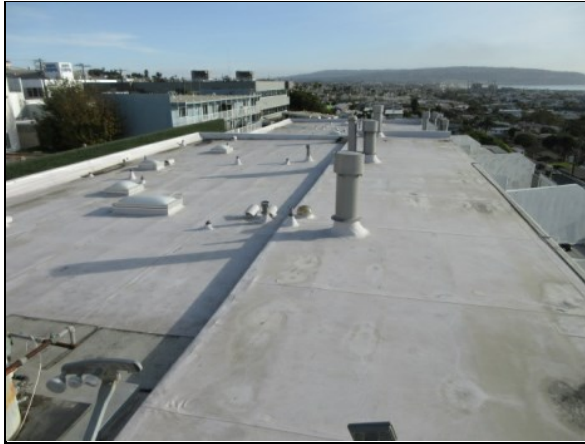
Comp #: 1307 Flat Roof (PVC) - Replace

Comments: PVC (Polyvinyl Chloride) roofs are known for their durability and longevity. When properly installed and maintained, a PVC roof can have an average lifespan of 20 to 30 years. However, it's important to note that the actual lifespan of a PVC roof can vary depending on several factors, including climate conditions, maintenance practices, foot traffic, and the quality of the installation. PVC roofs offer excellent resistance to UV radiation, chemicals, and weathering, which helps them maintain their performance over an extended period. They are also highly flexible and have good dimensional stability, allowing them to expand and contract with temperature fluctuations without cracking or breaking. Regular maintenance, including inspections, cleaning, and addressing any issues promptly, can help extend the life of a PVC roof. Regular inspections can help identify and address any potential problems before they escalate. Additionally, periodic roof coating or resealing may be necessary to maintain the roof's integrity and waterproofing properties. Some PVC roof systems may also benefit from a reflective coating to enhance energy efficiency and prolong the life of the roof. It's advisable to consult with a professional roofing contractor who specializes in PVC roofs for specific information about the expected lifespan of your particular PVC roof system and recommendations for maintenance to ensure its longevity.

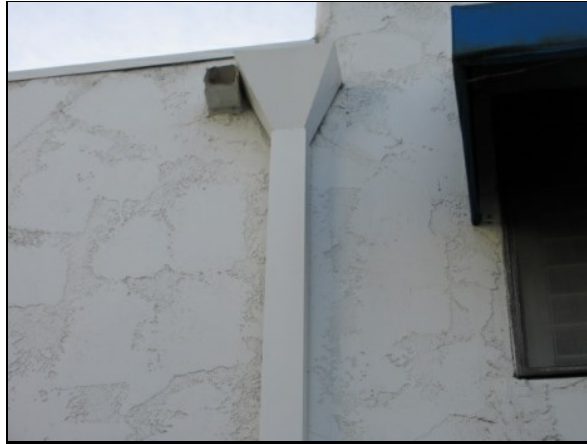
Comp #: 1310 Gutters/Downspouts - Repair/Replace**Quantity: Approx 2,200 GSF**

Comments: The gutters should be cleaned of debris on regular basis to allow optimal drainage. The cleaning projects and minor repairs should be handled as an Operating expense. Clogged gutters and downspouts will fail prematurely, while water runoff will stain the building exteriors and could lead to water intrusion, mold, and/or damage. Repainting is included with the building exterior repainting projects.

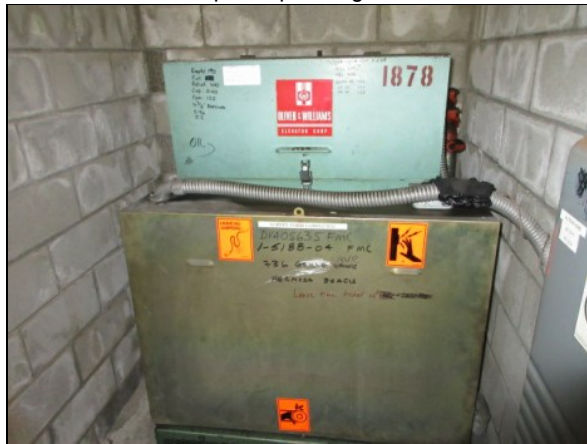
Comments: We are not licensed to inspect these systems. Not tested during inspection, but found to be operational. It was reported that the door package was replaced approx (2) years ago. Anticipate the need to modernize a hydraulic elevator every 20-30 years. Modernization consists primarily of replacing the controller, door operator, pumping unit, valve, tank, push-button fixtures & indicator fixtures, as any other code changes or upgrades required. Delaying or deferring this project can lead to unexpected failures and lengthy shut-down periods as replacement parts are ordered. Scheduling this project ahead of time will minimize "down" period of the elevator and allow for optimal planning.

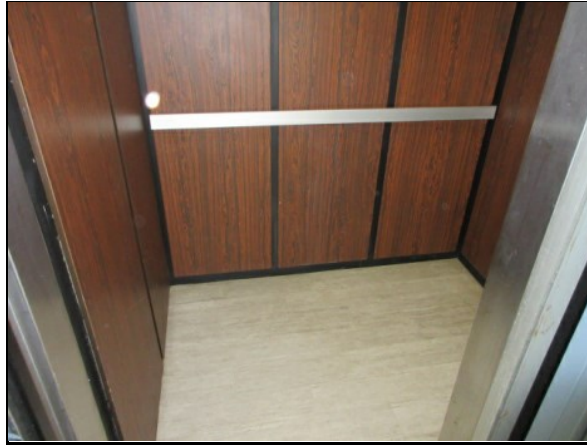
Comments: Funding for periodic remodeling projects to maintain an attractive appearance inside the elevator cab. This includes the replacement of the cab floor, wall panels, and grab-rails. Minor repairs and upgrades should be handled as needed as an Operating expense.

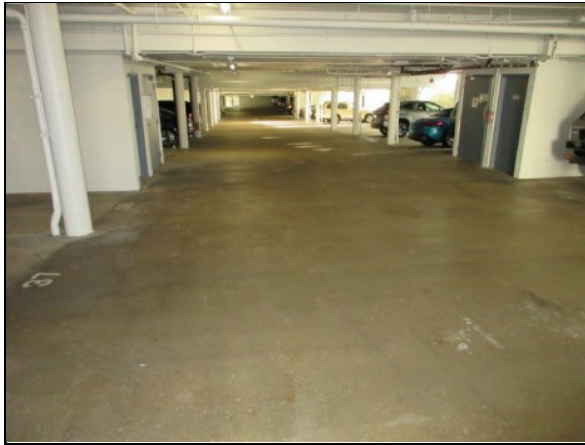
Comp #: 205 Concrete Driveway - Repair**Quantity: Extensive GSF**

Comments: There is no expectation for major repairs or replacement within the scope of this Study based on current conditions. Surfaces should be pressure washed on a regular basis to remove any tire marks and oil stains. These project should be handled as an Operating expense. Funding for parking space restriping is included with #1118. No additional Reserve funding is required. Surfaces should also be inspected on a regular basis for trip-hazards. Any trip-hazard repairs should be completed immediately as an Operating expense.

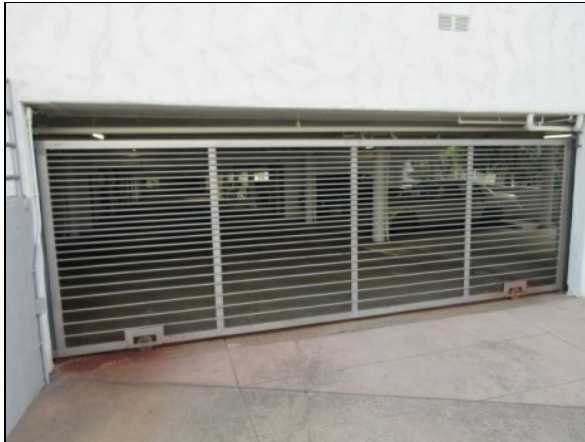
Comp #: 730 Vehicle Gate - Replace**Quantity: (1) Slider**

Comments: Normal operation observed during inspection. The useful life is based on the assumption that the repainting projects will be completed on schedule (refer to #1107). Ongoing maintenance should be handled as an Operating expense.

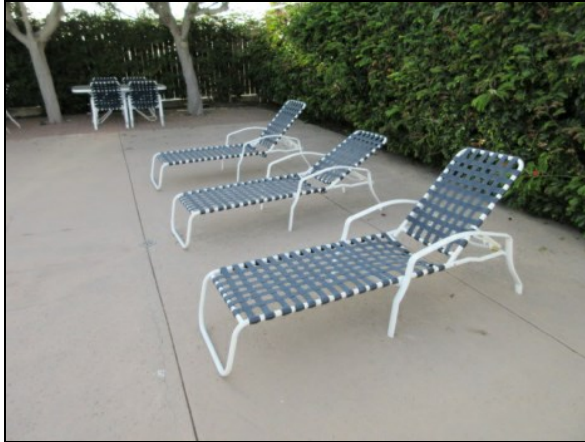
Comp #: 404 Pool Furniture - Replace**Quantity: (35) Assorted Pieces**

Comments: The furniture consists of (6) chaise lounges, (21) chairs, (7) tables, and (1) umbrella. Funding for ongoing complete replacement projects to maintain a uniform and attractive appearance.

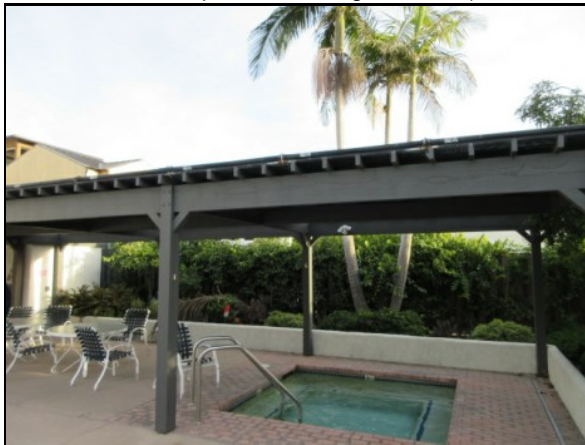
Comp #: 509 Wood Trellis - Replace**Quantity: Approx 645 GSF**

Comments: The wood trellis structures were in good condition. No signs of heavy cracking or dry-rotting. The useful life is based on the assumption that the trellis structures will be repainted on a regular basis (refer to #1116).
